KILKENNY - COUNTY GEOLOGICAL SITE REPORT

NAME OF SITE	Hugginstown M9 Cutting
Other names used for site	
IGH THEME	IGH 10 Devonian
TOWNLAND(S)	Ballygeardra, Carrickshock Commons, Coolmore
NEAREST TOWN	Hugginstown, Ballyhale
SIX INCH MAP NUMBER	Kilkenny 31
NATIONAL GRID REFERENCE	251985 133545 to 251903 134504 (east side) 251835 135006 to 251919 134025 (west side, northern cut) 251948 133627 to 251959 133523 (west side, southern cut)
1:50,000 O.S. SHEET NUMBER	67 1/2 inch Sheet No. 19

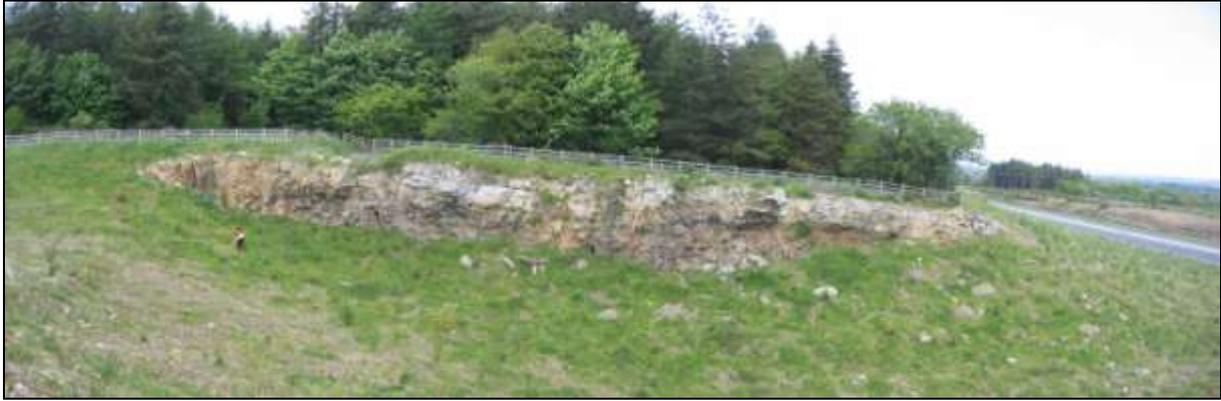
This side excavation could be made accessible with some fencing to the right to isolate it.

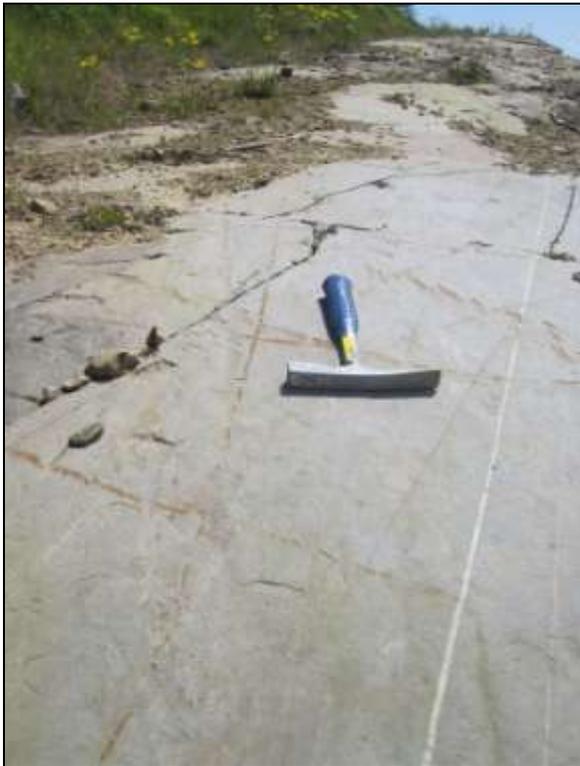
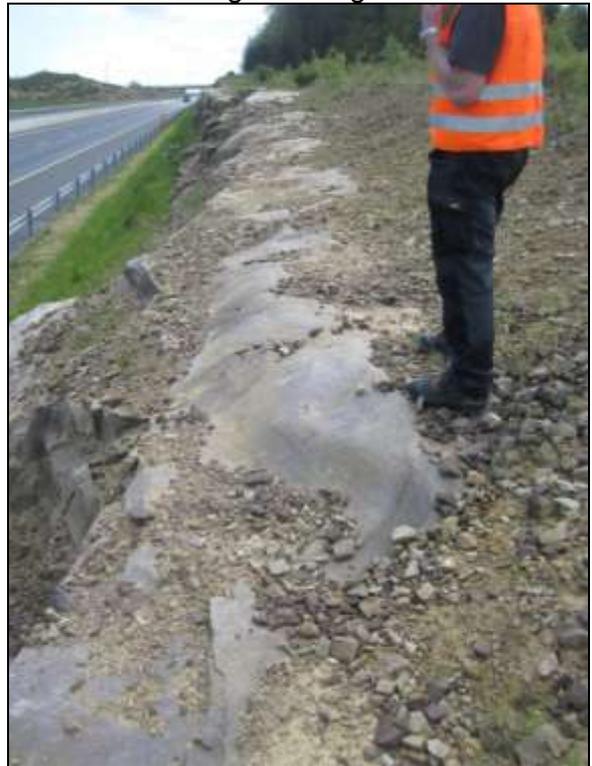
Glacial striae and gouges (left) and P-forms (right)

Of additional interest are glacial modifications to the rocks. Where hard sandstone beds occur, some show glacial striae and chattermarks. These are scratches and gouges on the surface of the rock, caused by the grinding action of rocks held within the base of an ice sheet as it moved over the locality. They are oriented 340° to 160°, basically north-northwest to south-southeast. In addition, on the western side a section of rock pavement shows what are known as P-forms. These are sculpted surfaces on the rock formed by meltwater erosion under high porewater pressures at the base of the ice, due to its great thickness.

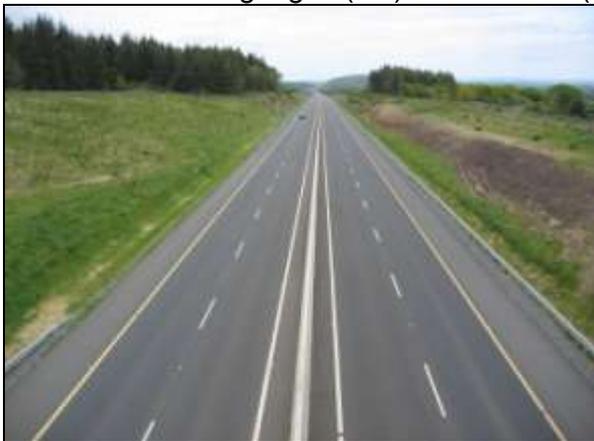
View of cuttings from the over bridge.

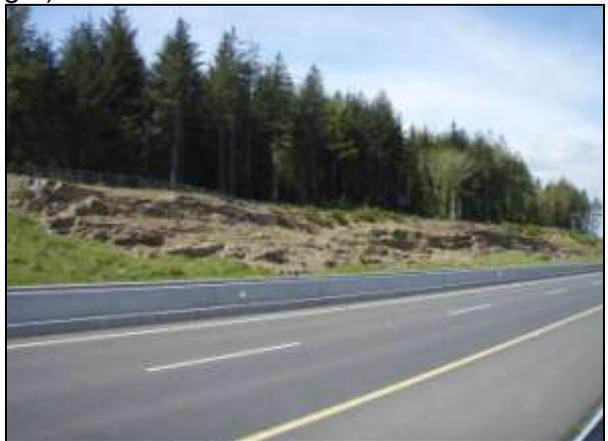
Thicker rock sections on the west side.
