KILKENNY CITY WALLS

CONSERVATION PLAN

Oxford Archaeology

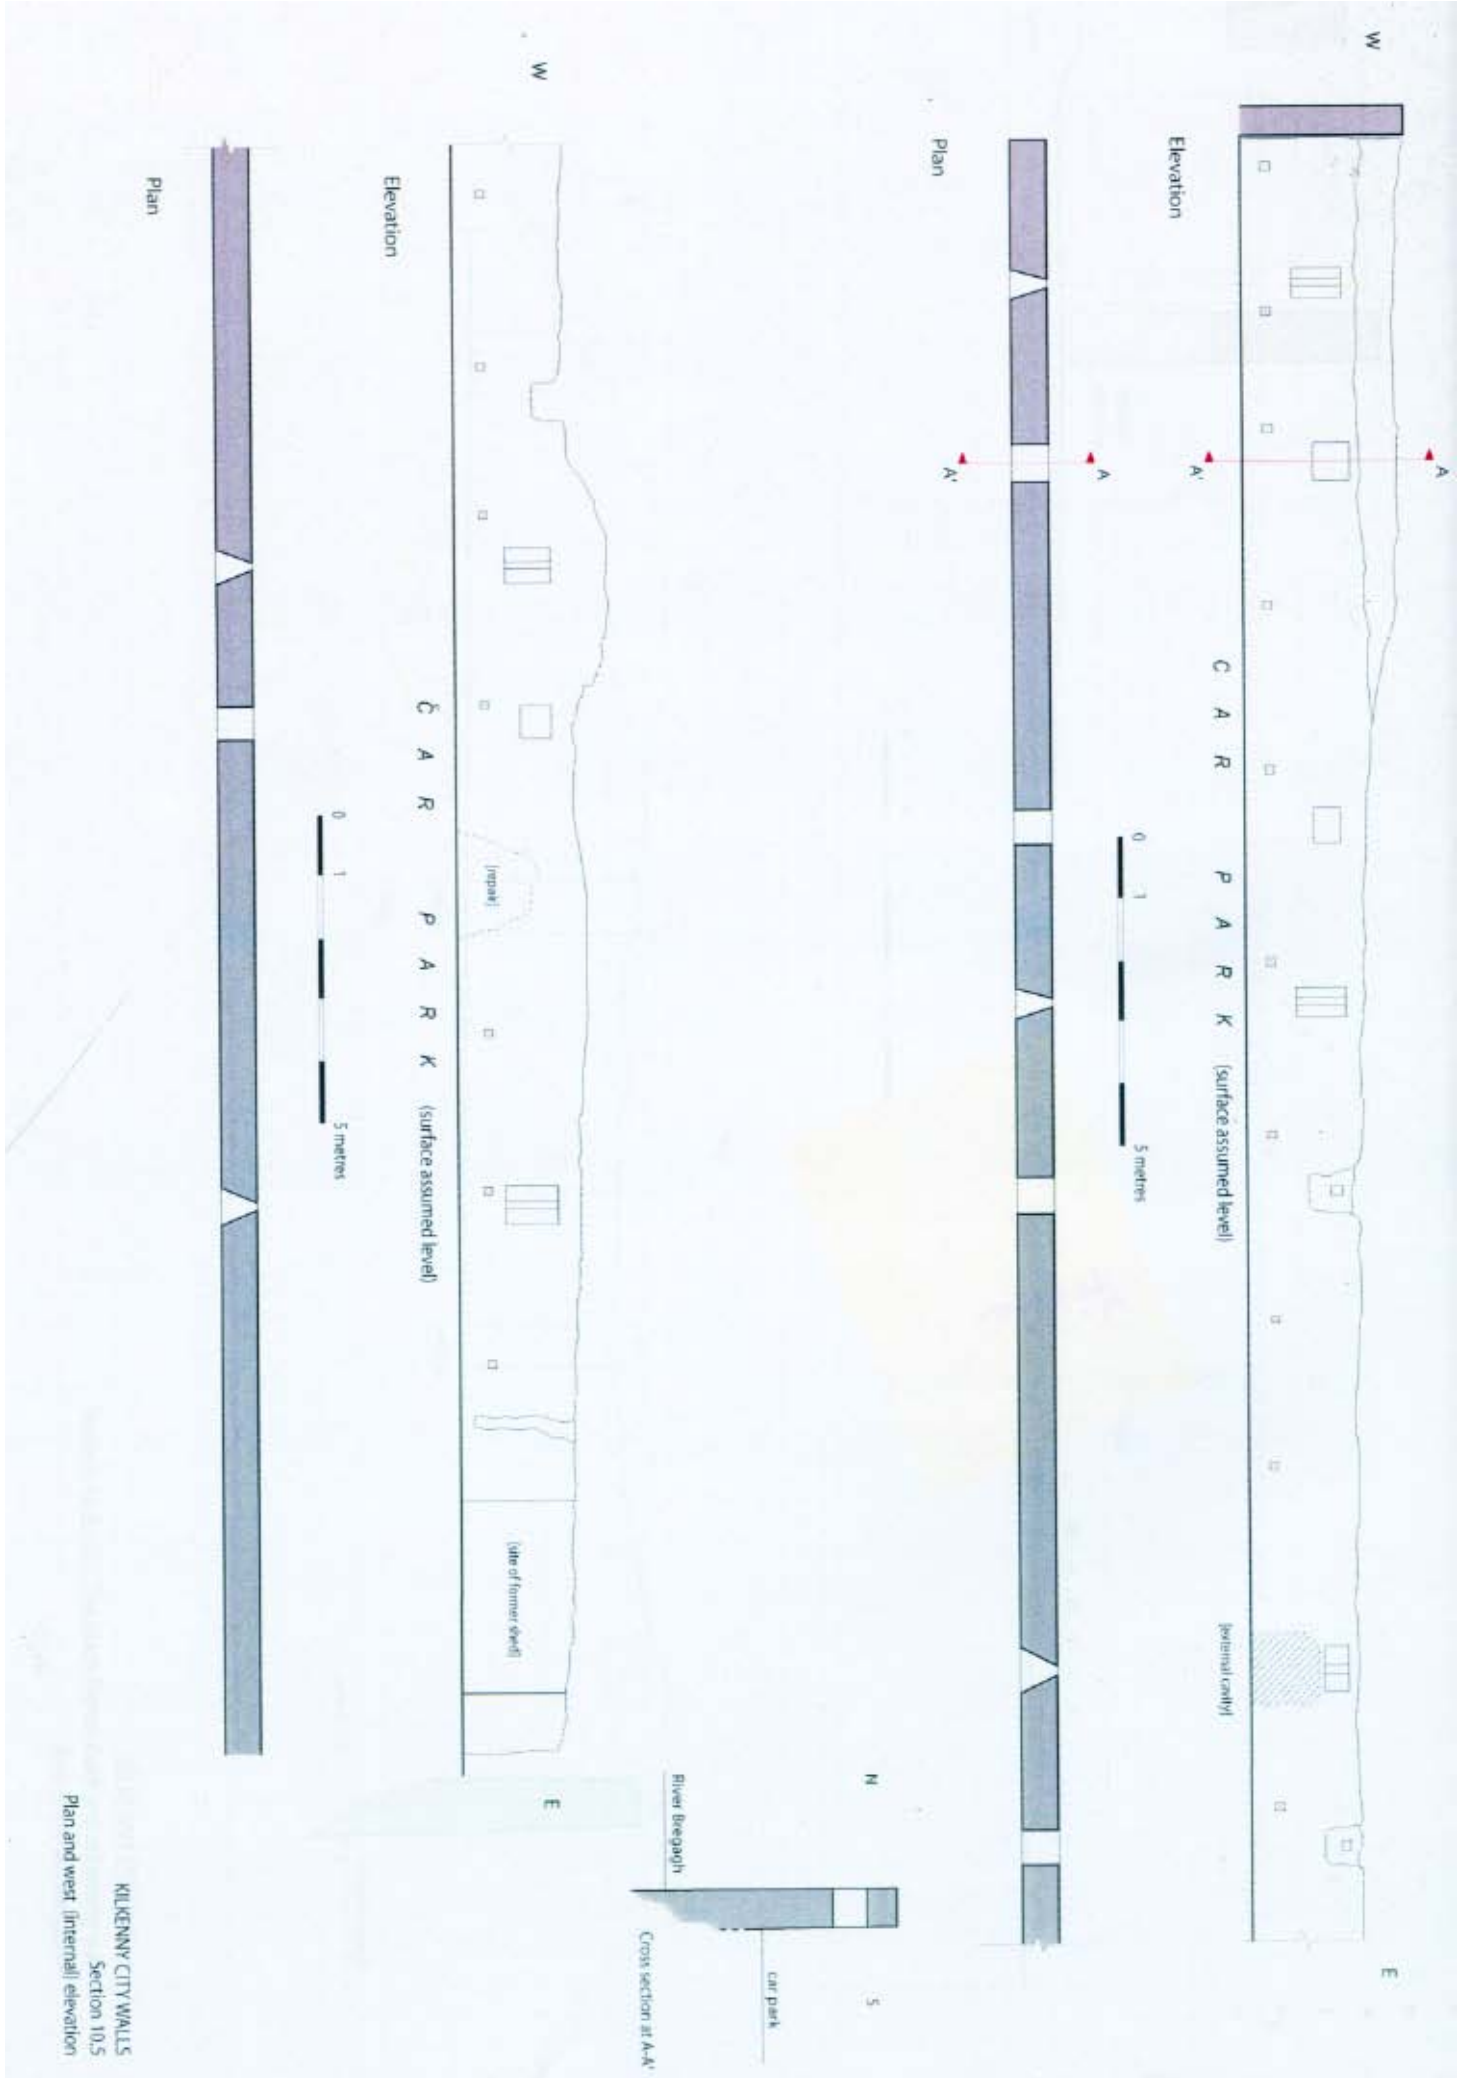
Figure 5: River Bregagh Frontage - Plan and west (internal) elevation

This section is visible from the northern bank of the River Bregagh; the interior is also accessible from the car park of the residential development on the south bank immediately north of the Black Friars Gate (Section 10.6). The wall survives to a maximum length of 57.5m and stands to a maximum height of 2.8m at the western end, although the upper courses here represent rebuild. For much of its length, the wall stands to a height of between 1.8m and 2.4m. Externally, the level of the river is *c.* 2m below the internal ground level. A total of ten openings of varying forms survive along the length of the wall. Of these, five are of splayed form with narrow (0.1m wide) external openings and internal dimensions averaging 0.8m tall x 0.6m wide. The splayed openings, which are late or possibly post-medieval in date, are arranged at fairly regular intervals of between 11m and 12m. Other openings are rectangular in form and display perpendicular jambs. Two of the latter openings have been partially blocked, leaving a reduced, square central opening. A level line of 17 putlog holes at 2.5 - 3m centres are located at a height of *c.* 0.45m above the internal ground surface.

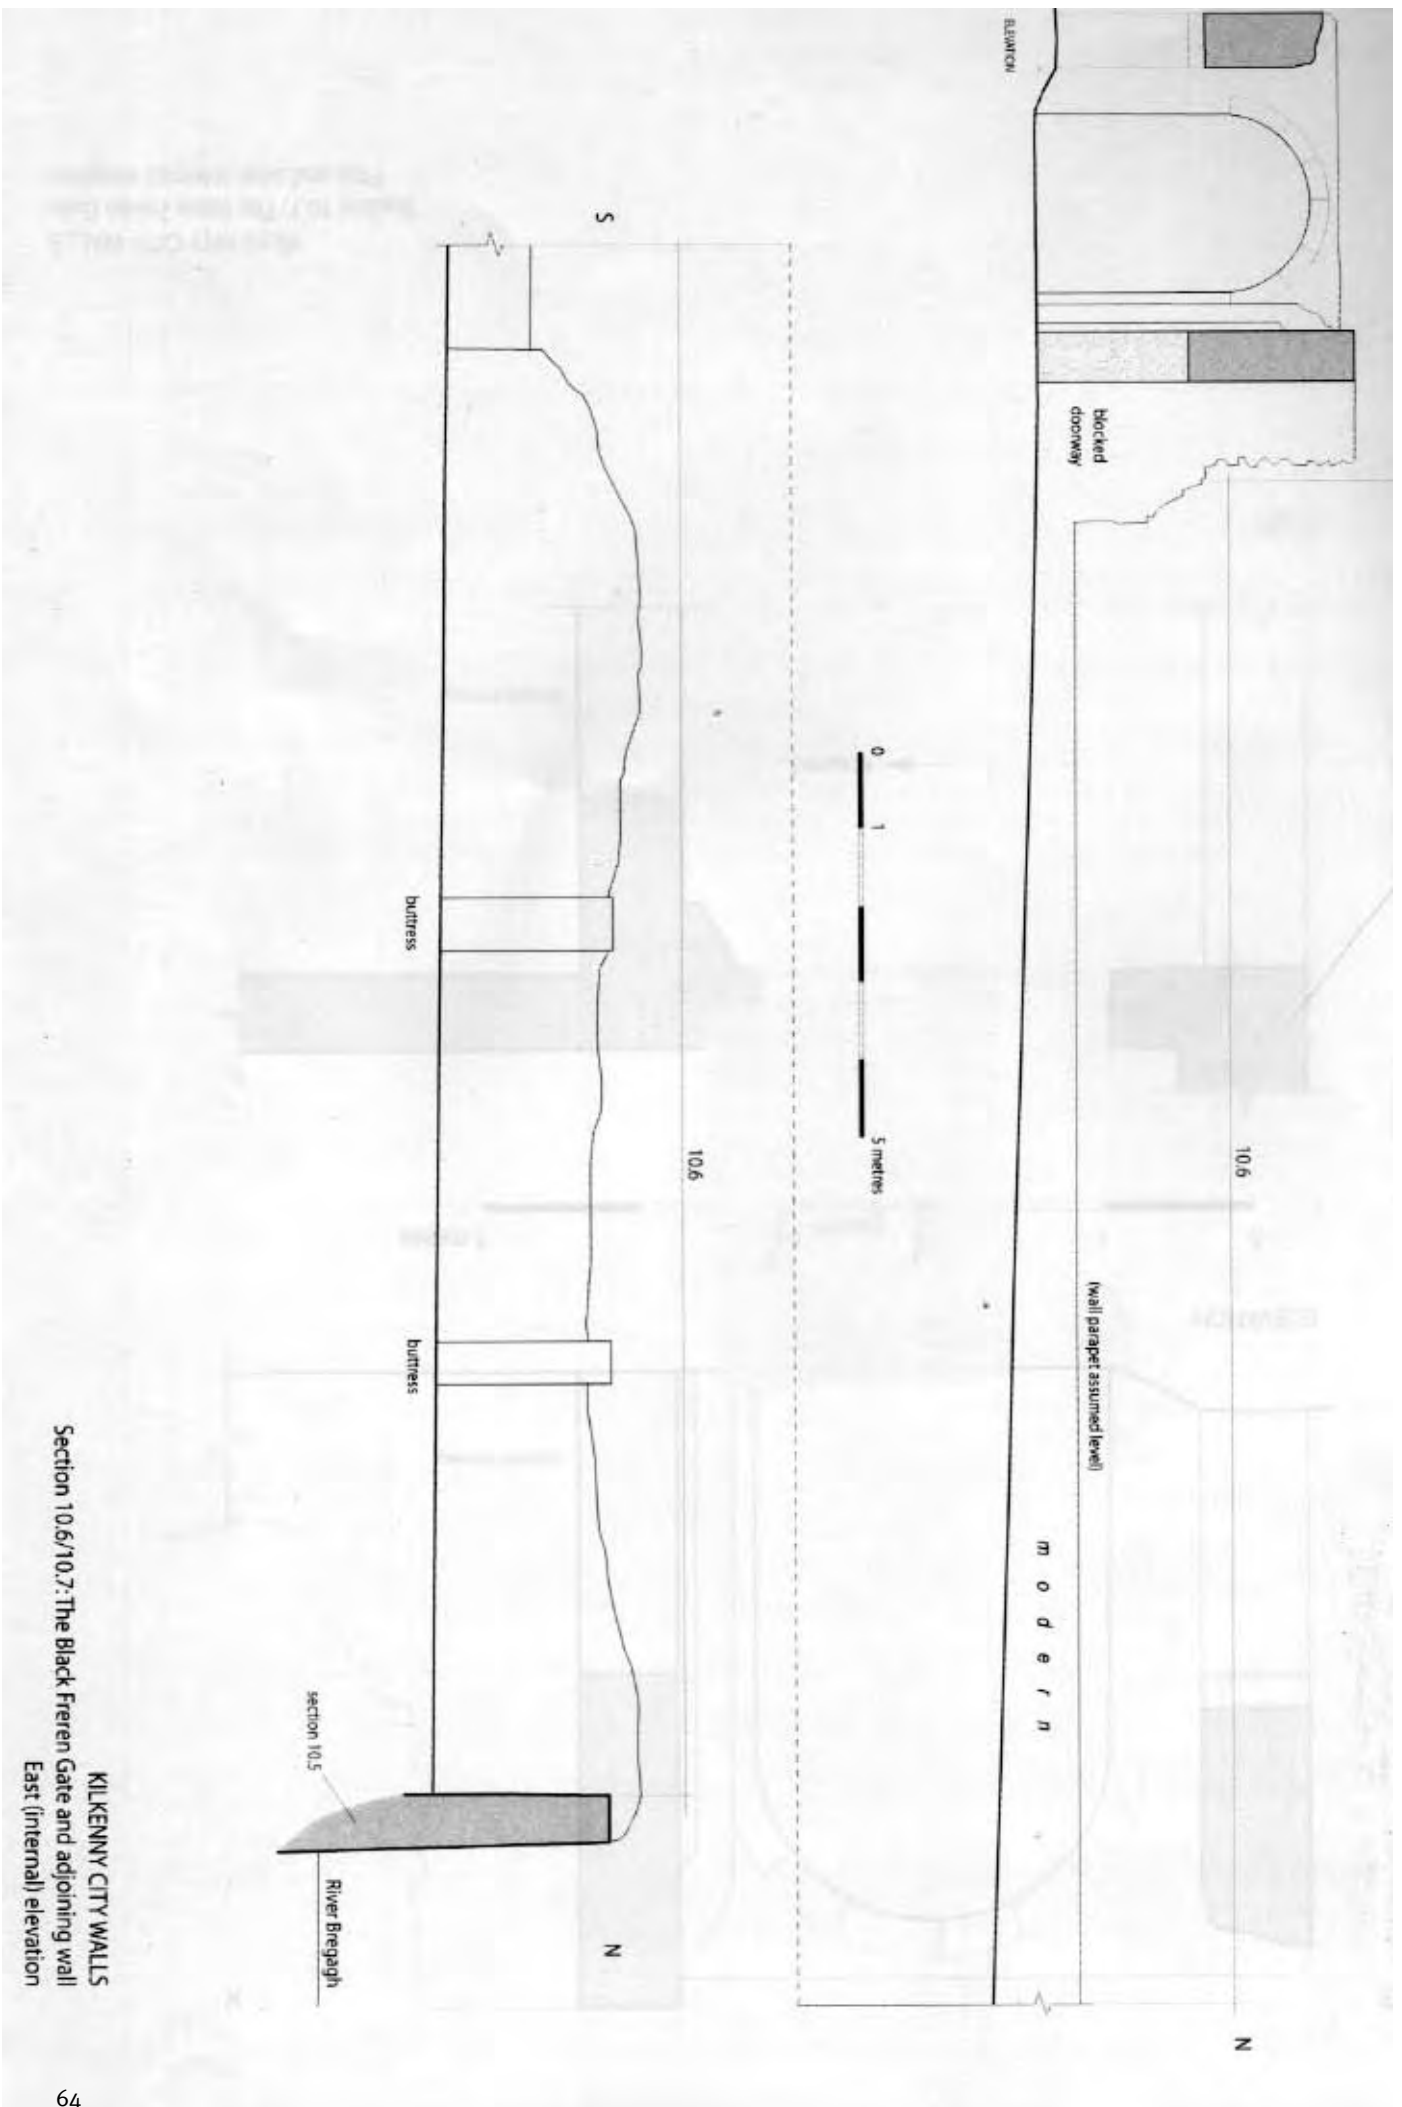
Figure 6: Black Friars Gate and adjoining wall. East (internal) elevation

The southern section of the wall is *c.* 21m in length and is a minimum of 0.5m and a maximum of 1.25m high. Although the wall reflects the historic mapped line of the city wall, the structure itself is clearly modern, rebuilt probably at the time of the construction of the carpark for the present residential development in the last decade. At its southern limit, it adjoins the northern side of the Black Friars Gate. While the northern part of the wall is of greater antiquity, its phasing is uncertain (the buttresses are bonded into the wall), and it may be post-medieval in date. It extends for 19.2m and is a maximum of 2.8m high, supported on its eastern (internal) side by two stone buttresses. At its far northern limit, the wall would appear to be abutted by the east-west riverside wall (10.4), the joint between the two being ragged in appearance.

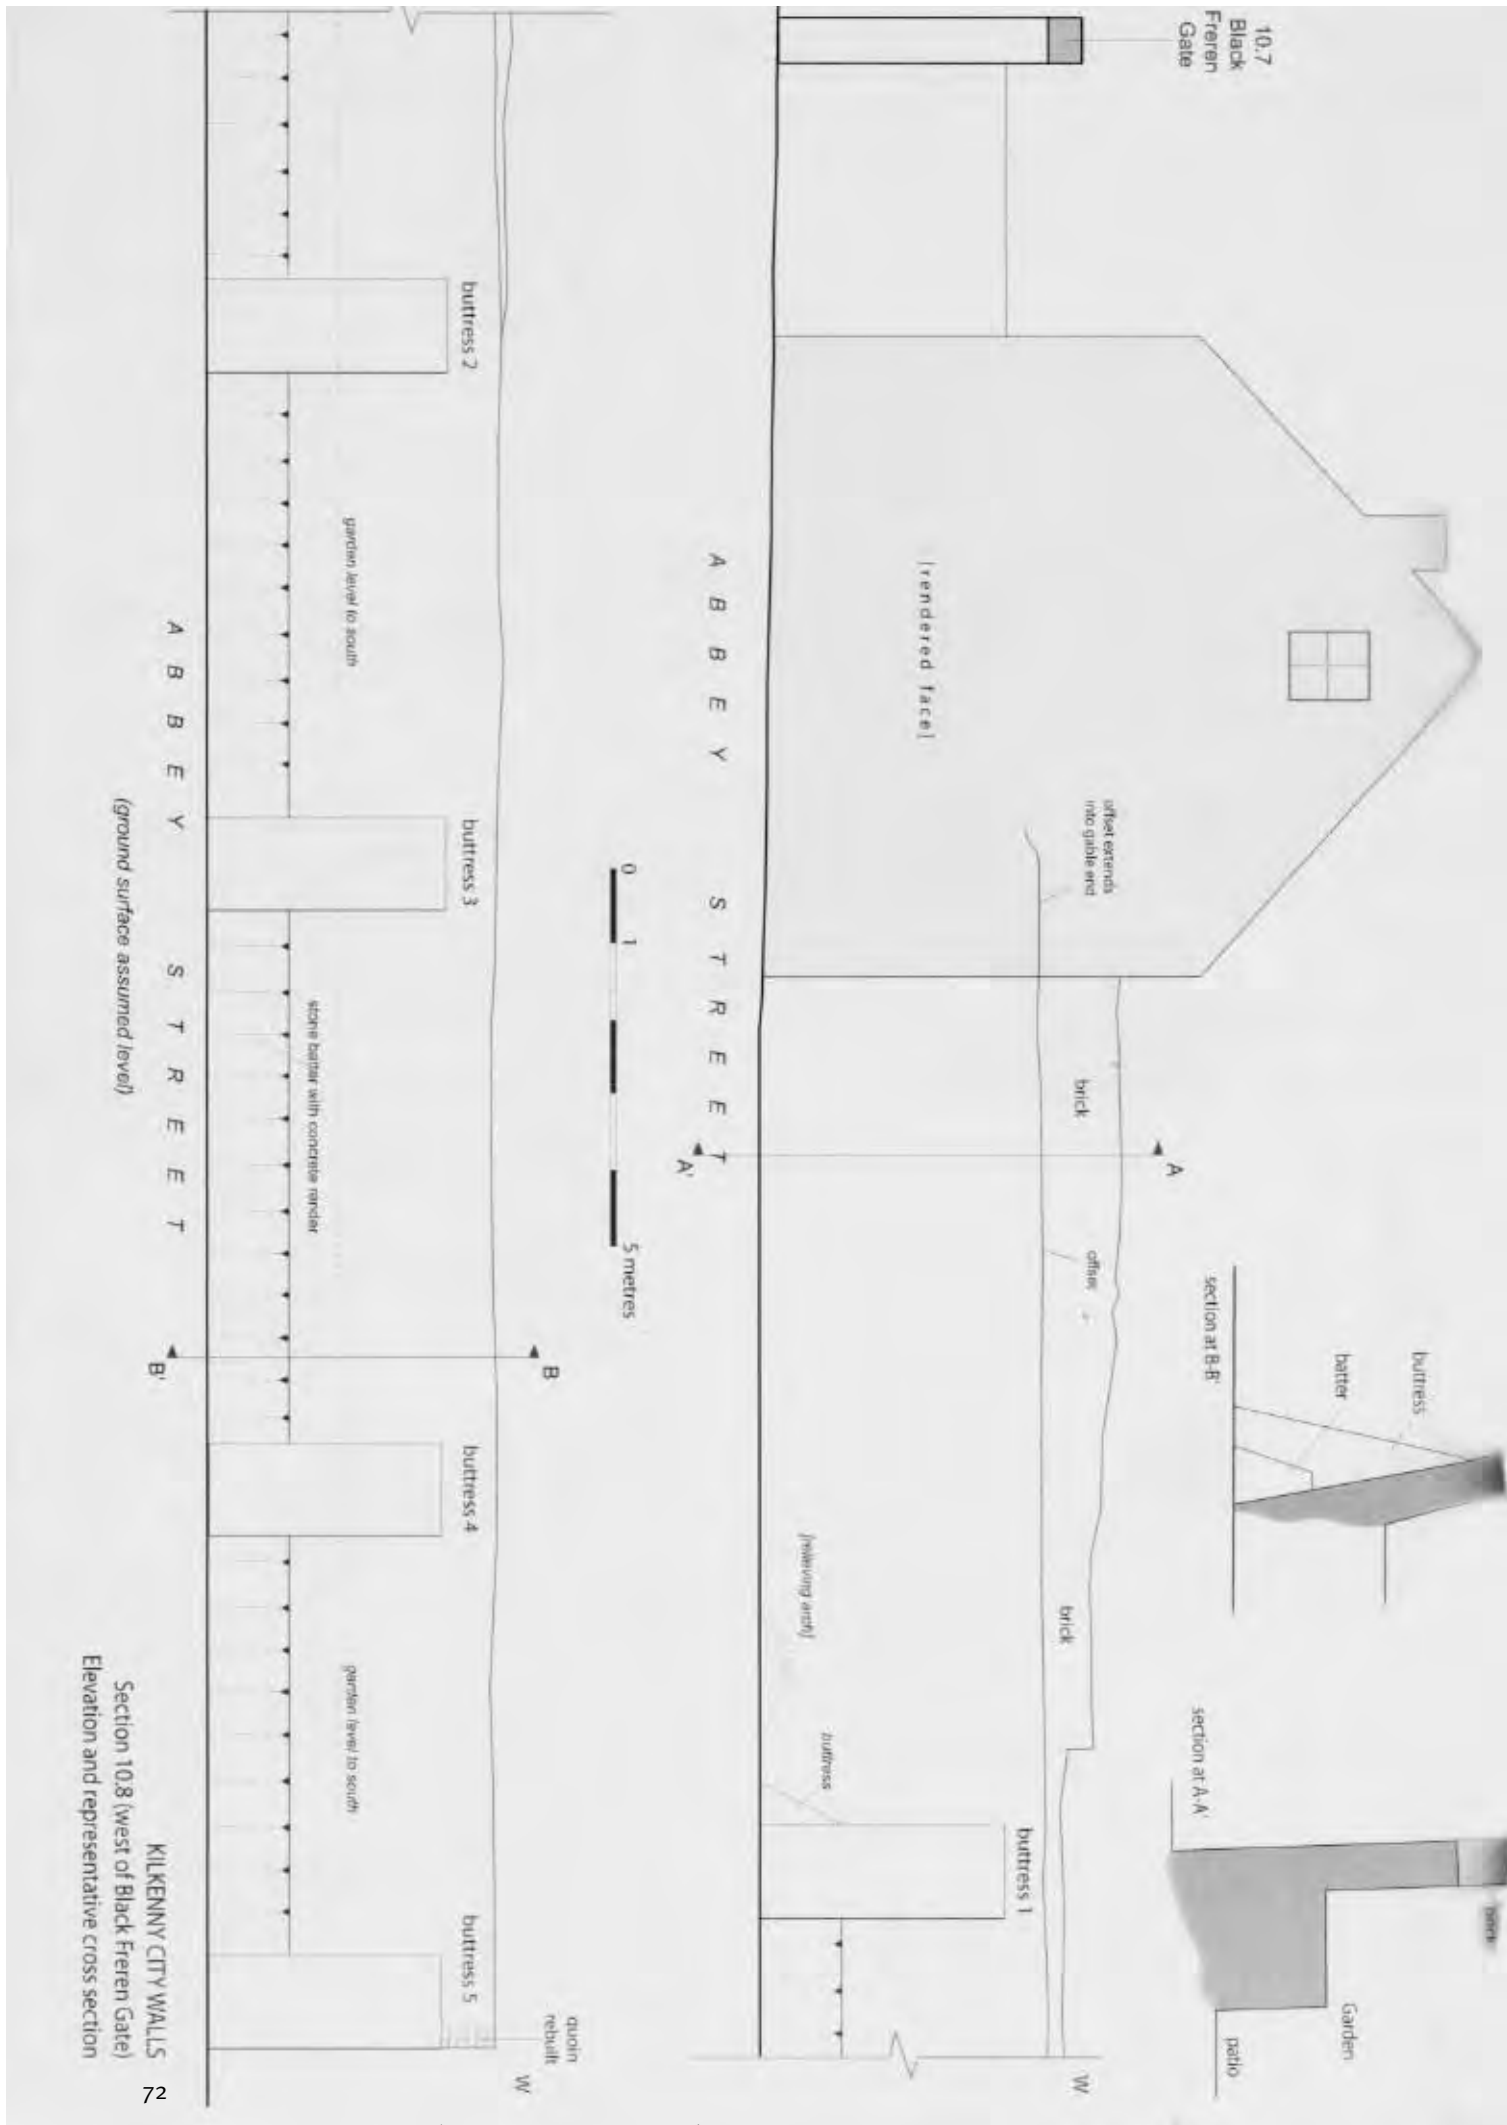
Figure 8: Abbey Street (west of Black Friars Gate). Elevation and representative cross-section

Plate 5: Section of City Wall flanking Abbey Street from the west (May 2001)

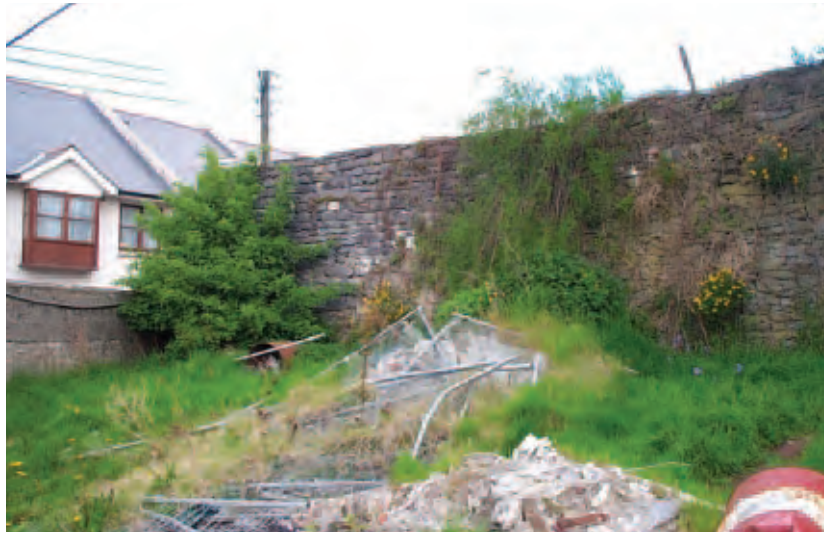
The northern end of wall, which forms the retaining wall for a garden and continues around the corner (10.8), has been entirely rebuilt in regular, angular grey limestone blocks up to and including the western quoin (Plate 6). Beyond this point, the wall is heavily overgrown with elder and sycamore, but is apparently built of rough battered (*i.e.* sloping) masonry, with some shuttered concrete repairs. The wall stands on top of a natural slope and internally stands as a low parapet, with a row of cypress trees inside it.

Plate 6: The northern end of the wall is heavily overgrown with elder and sycamore

- Protection of the wall from damage from growth of trees and shrubs. [Policy 9]
- Clearance (as part of landscaped scheme) to allow wall to be seen. [Policy 17]
- Detailed survey and analysis of surviving fabric. [Policies 12, 14]
- Condition survey to determine necessity of any structural repair. [Policy 11]
- Archaeological record of any alterations or maintenance works. [Policy 15]

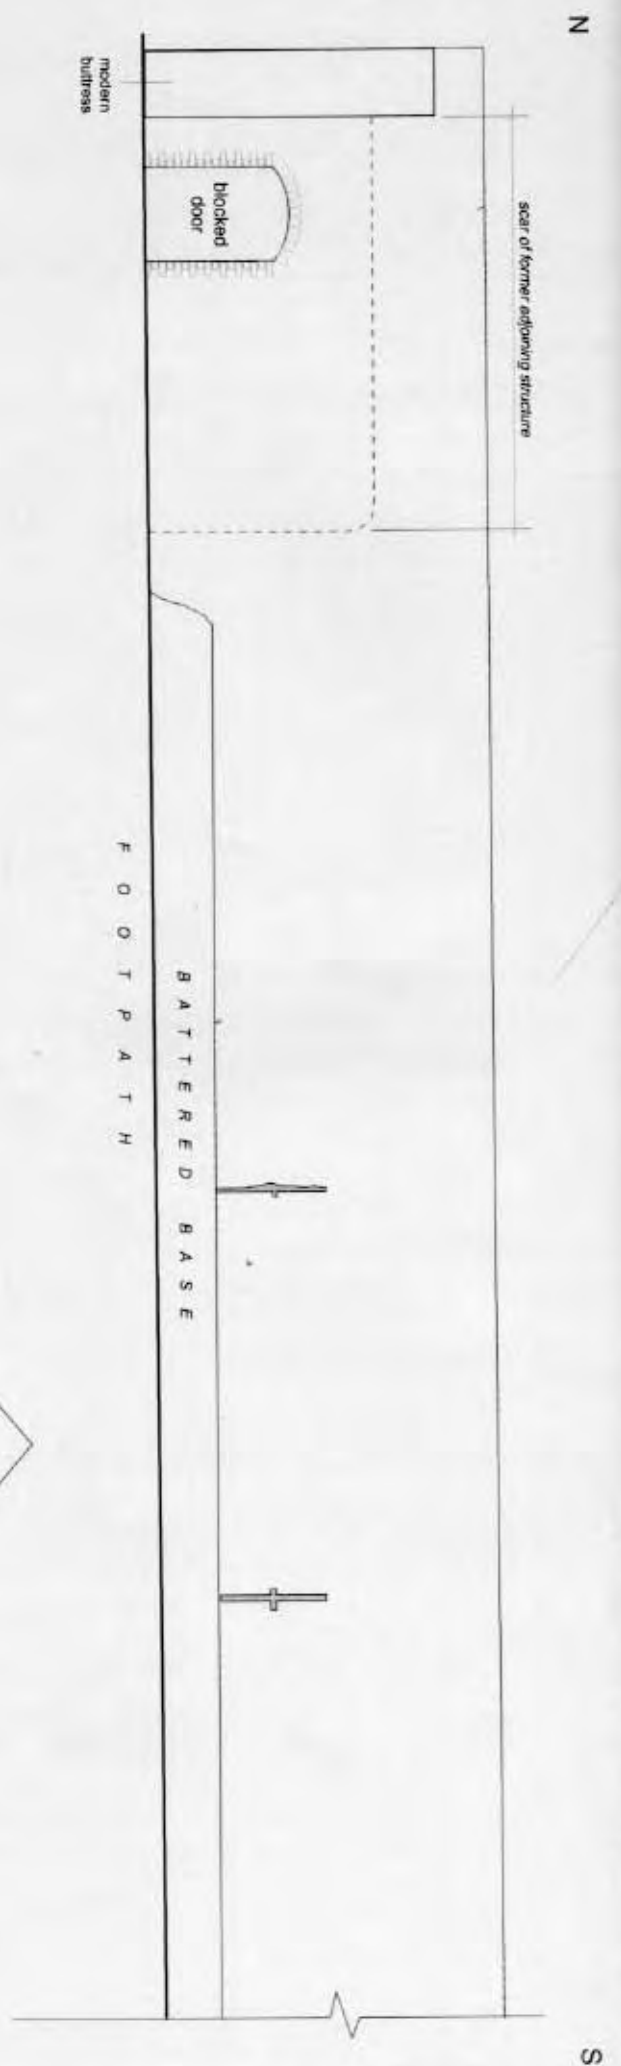
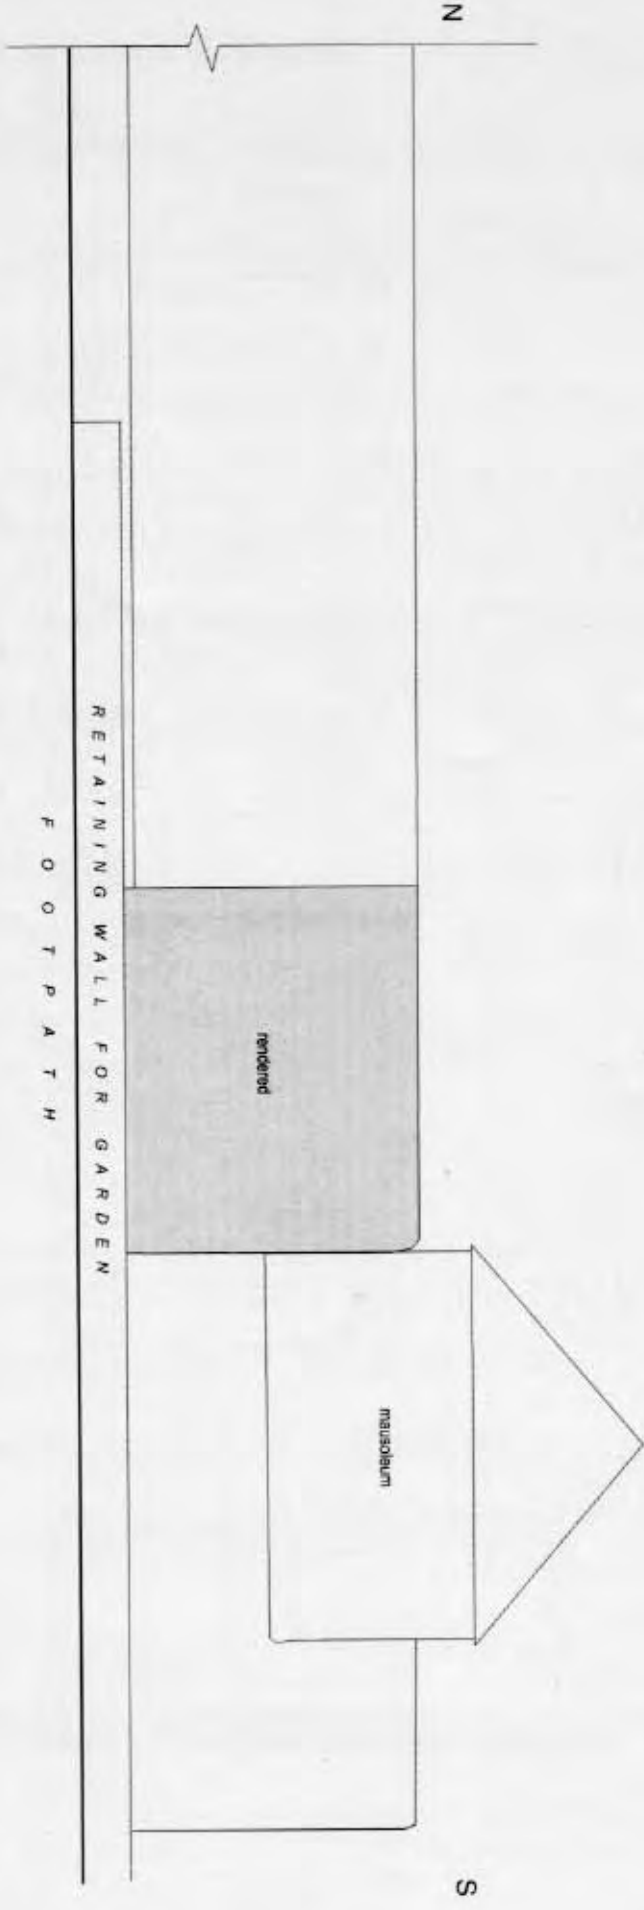
KILKENNY CITY WALLS
Section 10.13
External elevation

This section of wall represents one of the best preserved and most readily accessible parts of the city circuit. Situated half-way along the western wall line to the south of James Street, it is 49.5m in length, 4.6m tall and 0.55m wide. The upper courses are modern. There are two arrow embrasures and a battered external plinth. The embrasure loops measure 1.4m in height and 0.09m in width. The southern example is the better preserved and is of cruciform type.

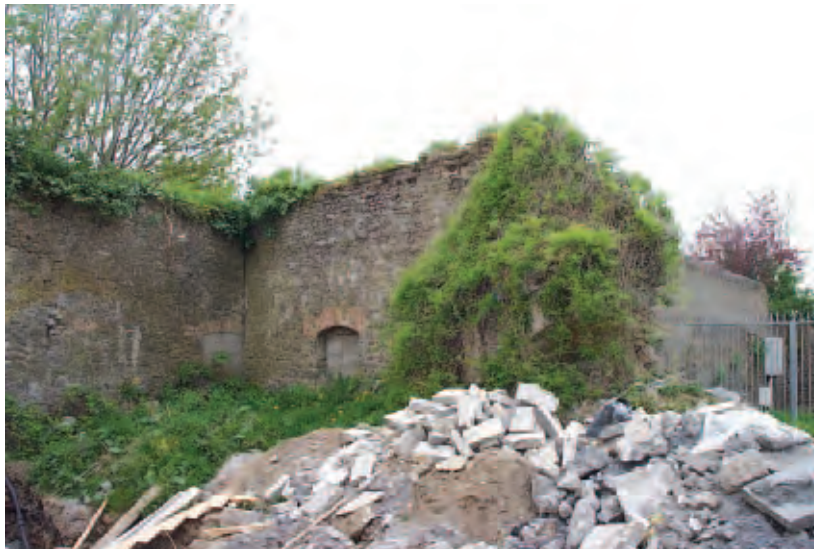
Lost length of c. 8m at north end (approximately on line of metal fencing). Wall to south of this is 49m in length and includes the remains of Myles Tower (Section 10.20). The wall is 4m high and 1.7m wide. The upper courses may not be original. It is pierced by two doors of modern origin, both of which are now disused. A structure (probably a former garden house) is built up against it, with several doors and windows of 18th or 19th-century date. A portion of the wall (then behind the *Kilkenny Journal* Office) was damaged during a storm in 1947 and a concrete wall was erected in its place (Bradley 1976, 213). The west side of the wall, at No. 6 Lower New Street, has been the subject of a detailed archaeological survey which concluded that the wall had 'undergone several phases of modification and considerable rebuilding and/or refacing in the course of its history, most likely during the 17th century and later' (Figure 8, OA report to Judith Carroll & Co. Ltd, 2001).

Plate 10: A length of wall, part standing and part lost, behind the Ormonde Hotel (Nos 29-32 Patrick Street)

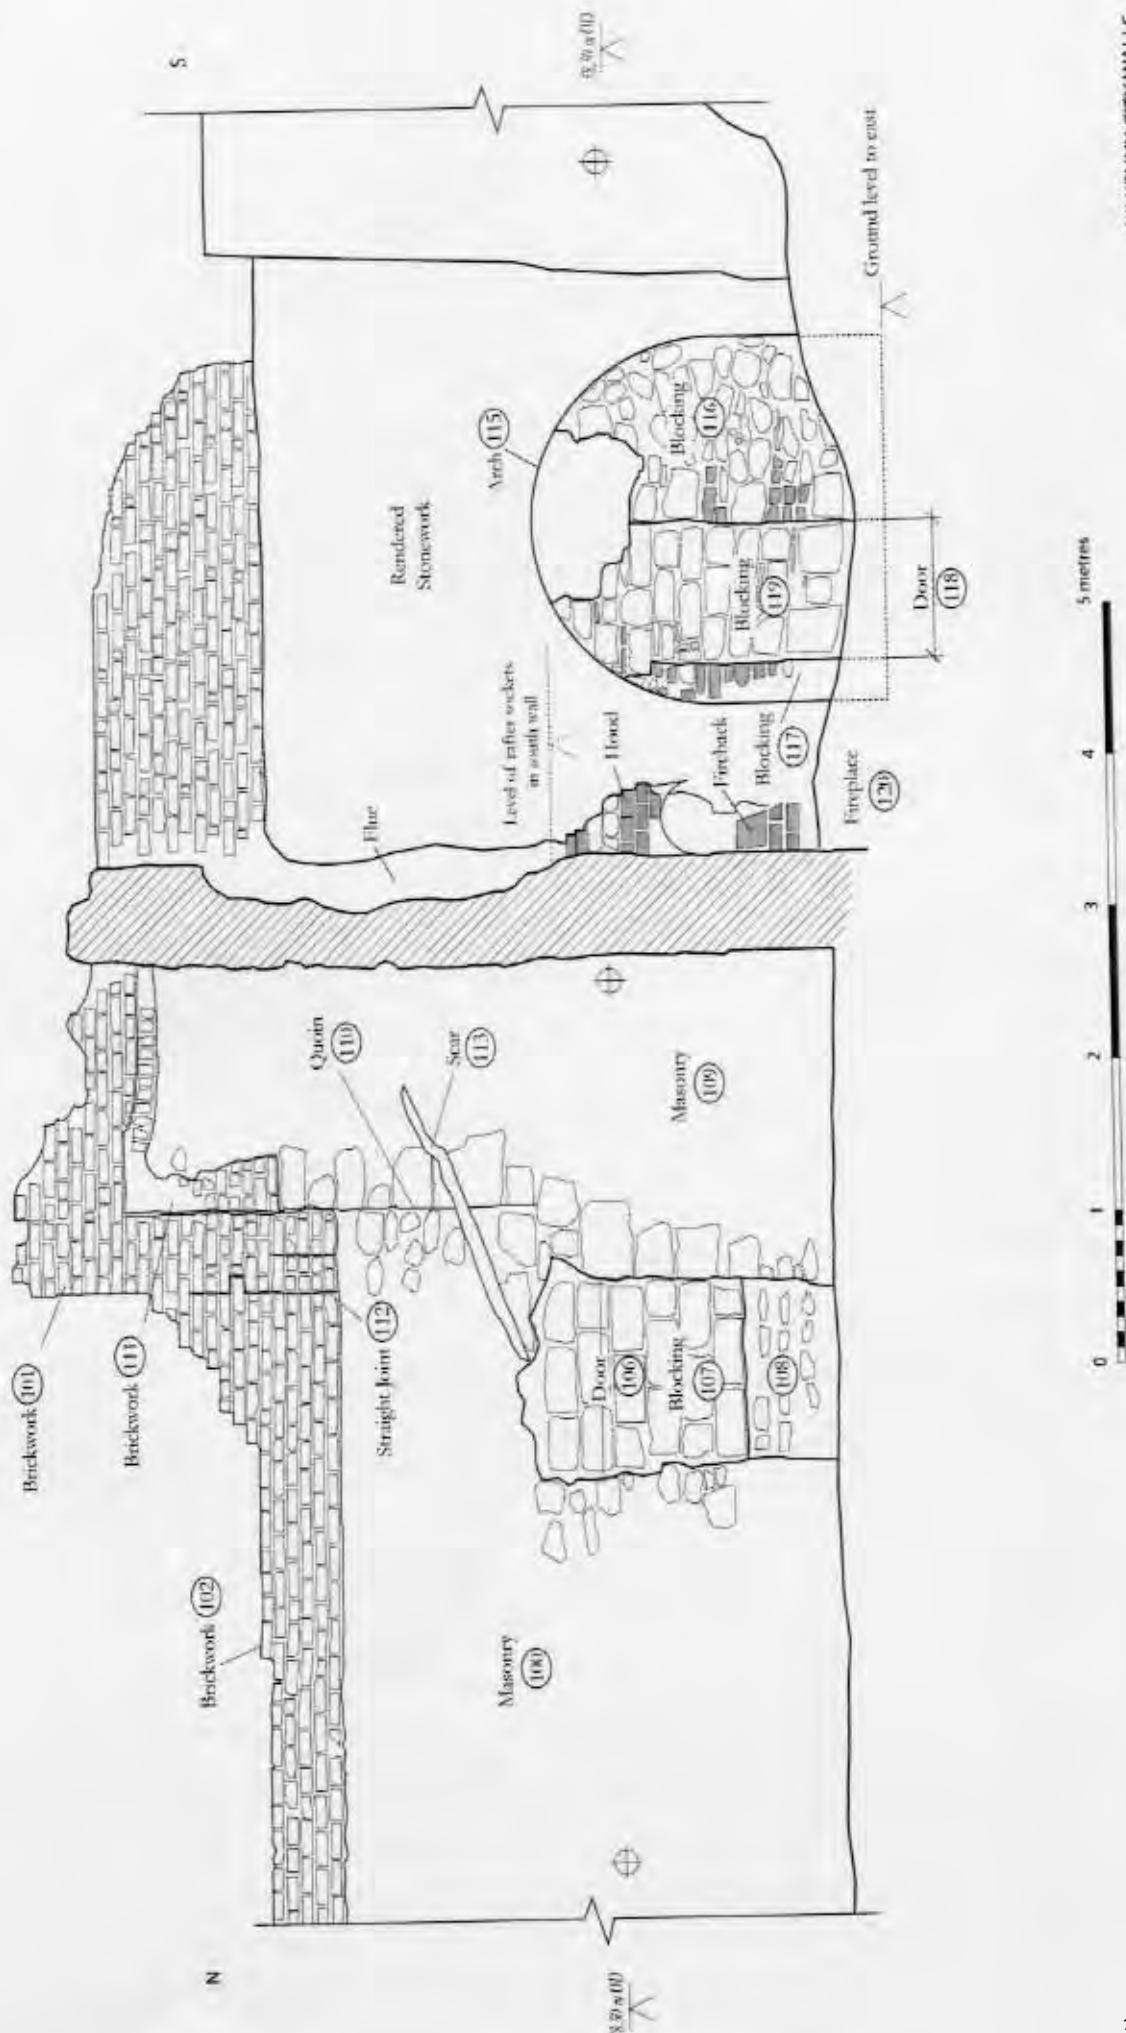
Survey: OAU September 2001

The condition of the masonry is poor to fair, but the staircase against the wall has been part demolished. A concrete walkway and platform have been constructed inside the wall as the base for the hotel's water tank.

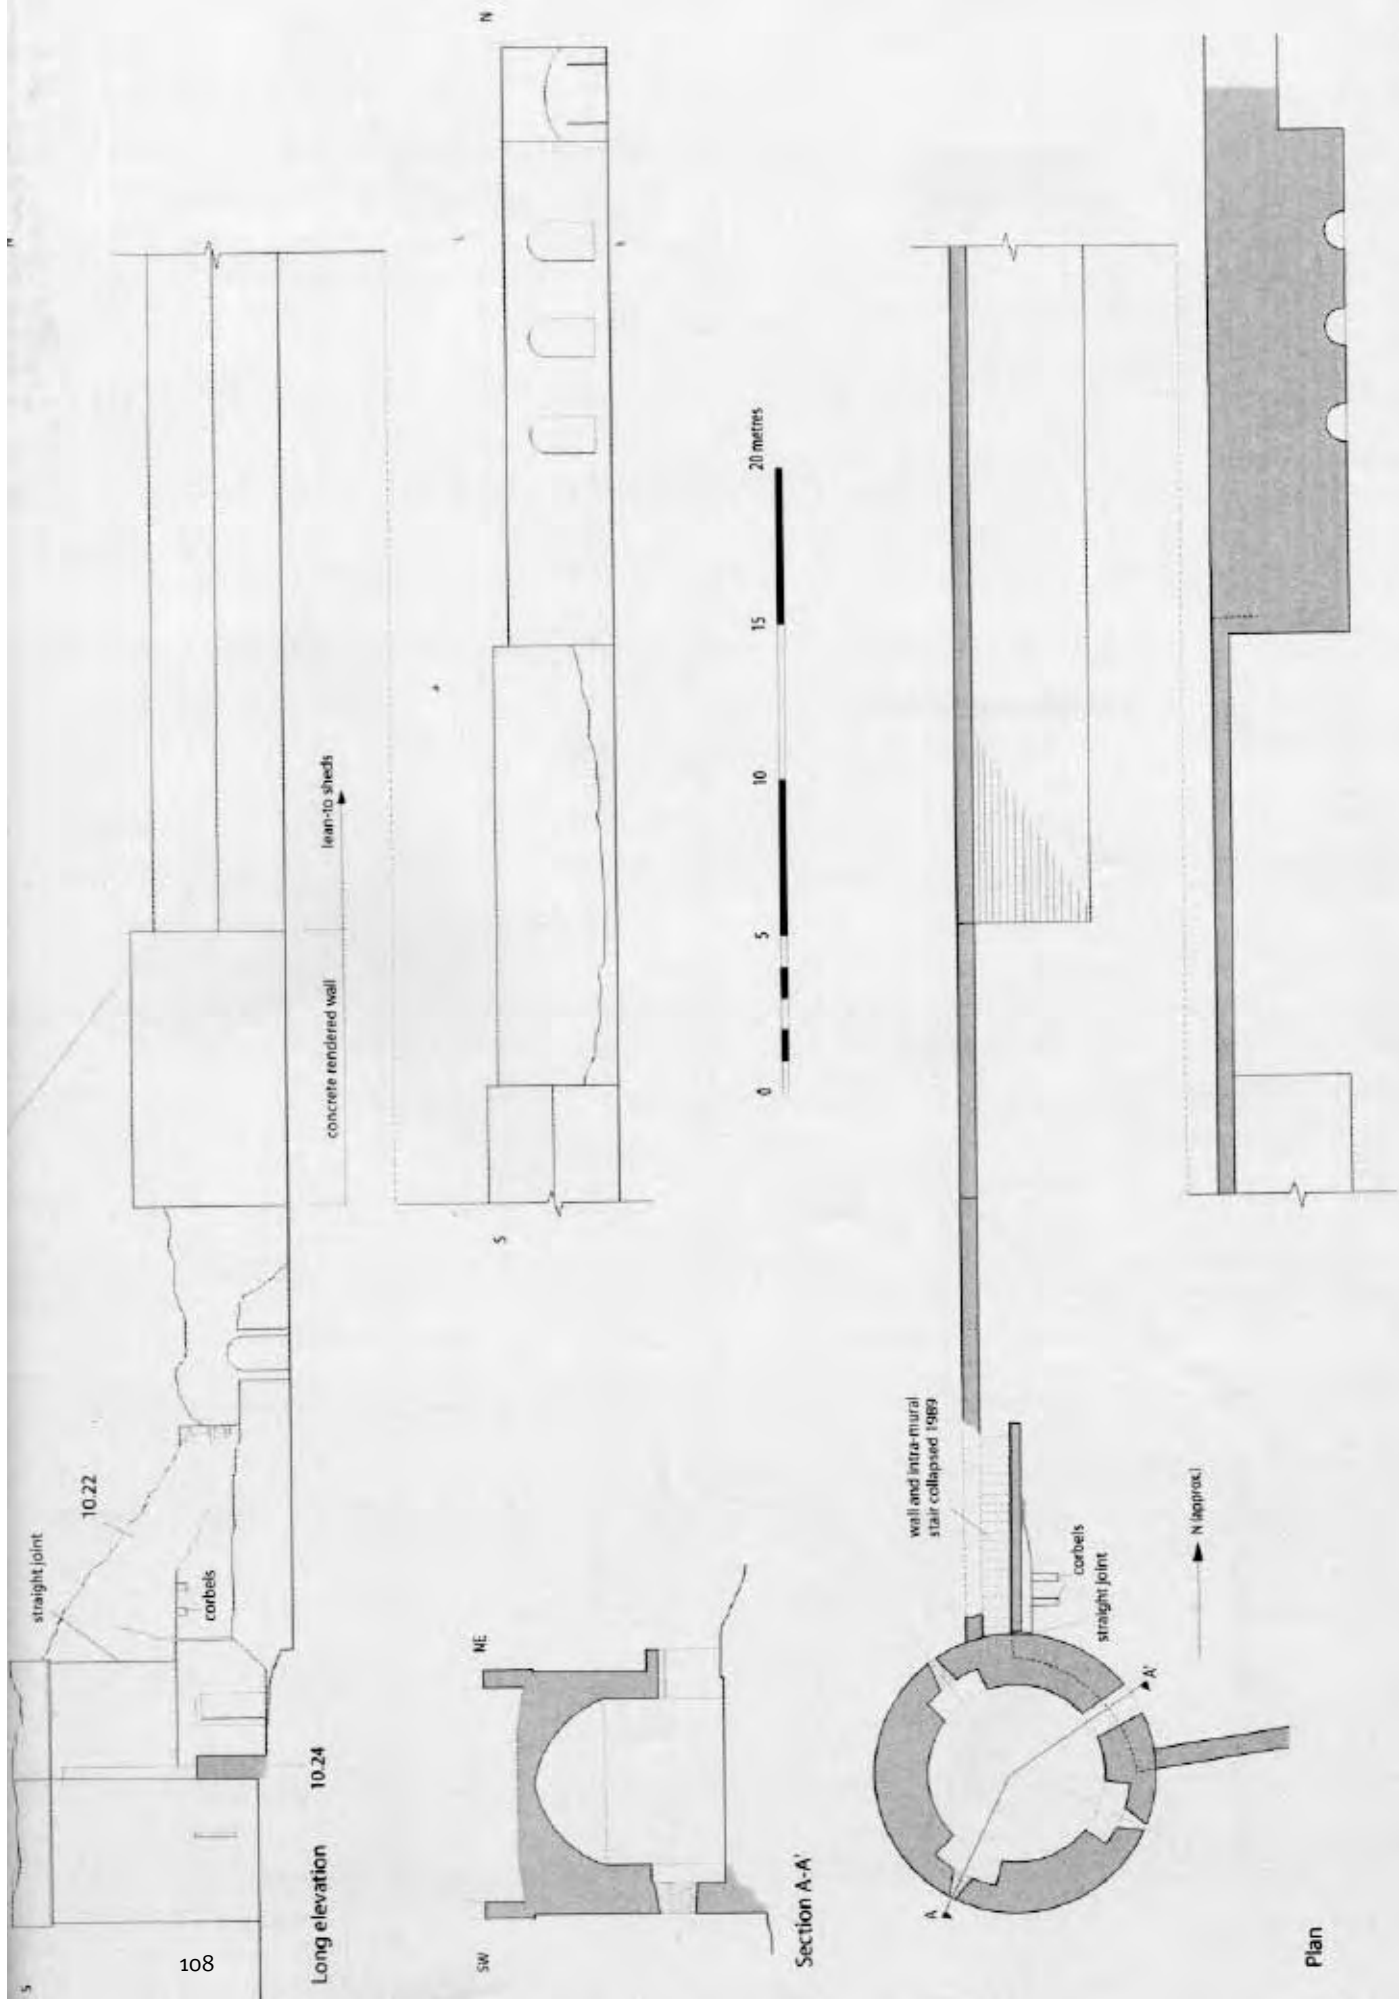
KILKENNY CITY WALLS
 Section 10.22, 10.23 (Talbot's Castle) and 10.24
 Plan, cross section and long elevation

The tower is located in the angle of Ormonde Road and Lower New Street. It formed the south-west angle of the city's defensive wall, which returns east at an acute angle. Talbot's Castle represents the most complete defensive feature of the city circuit, comprising a circular tower standing to a maximum height of 9.7m, 5.58m in diameter internally, with walls 1.65m thick. There is open space east and west of the tower, while to the south, the tower is abutted by the back yards of three houses (Nos 12-14 Ormonde Road), which date from c. 1860, unless they are the buildings that were present in 1841.

- Detailed survey and analysis of surviving fabric. Investigation of relationship to adjacent structures. [Policy 14]
- Careful maintenance of vegetation, and removal of unsuitable woody species (ivy, sycamore, elder). [Policies 9, 11]
- Establishment of maintenance regime. [Policy 11]
- Monitoring of condition of fabric to determine any need for repairs. [Policy 11]
- Careful recovery and investigation of collapsed fabric. [Policy 12]
- Rebuilding of steps to top of tower, and consideration to re-creation of wall-walk. [Policy 18]
- Archaeological record of any alterations or maintenance works. [Policy 15]
- Consideration of best means of presenting the site (external and internal access, opening vistas and spaces, information and display) as a key element of the Kilkenny defences, and in relation to adjacent wall sections. [Policies 19-22]

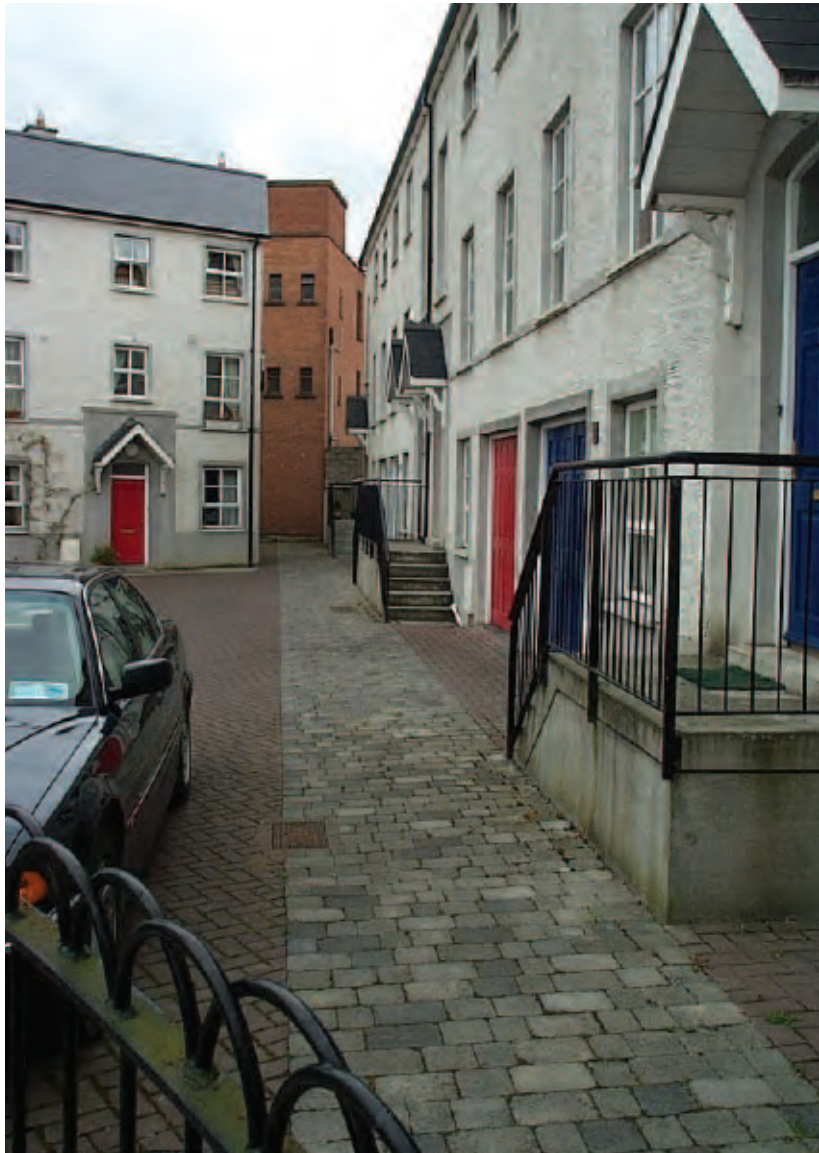
Plate 14: Line of City Wall delineated in grey stone paviours, Ormonde Road (May 2001)

- Protection of below-ground remains of the defences. [Policy 6]

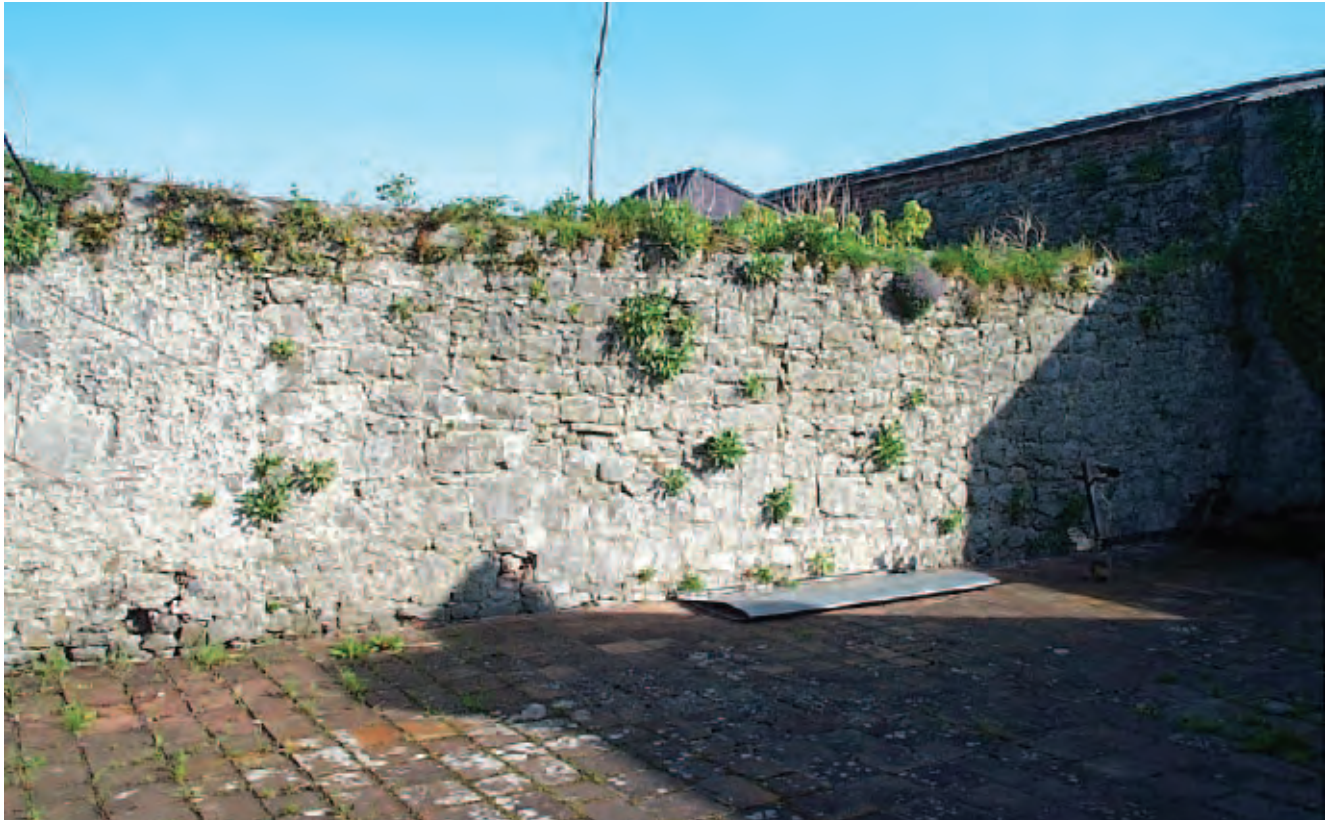
The masonry is of roughly dressed and coursed angular grey limestone blocks. A single vertical loop is visible on the external elevation of the wall, measuring 1.25m tall by 0.08m wide. The loop is not visible to the internal face of the wall where it is obscured by the raised ground level.

Plate 17: City Wall viewed from the south-east (exterior) (May 2001)

- Detailed survey and analysis of surviving fabric. [Policy 14]
- Careful maintenance of vegetation growth on wall (removal of unsuitable woody species). [Policies 9, 11]
- Monitoring of condition of fabric to determine any need for repairs. [Policy 11]
- Establishment of maintenance regime. [Policy 11]
- Archaeological record of any alterations or maintenance works. [Policy 15]
- Consideration of display and access. [Policies 19, 20]

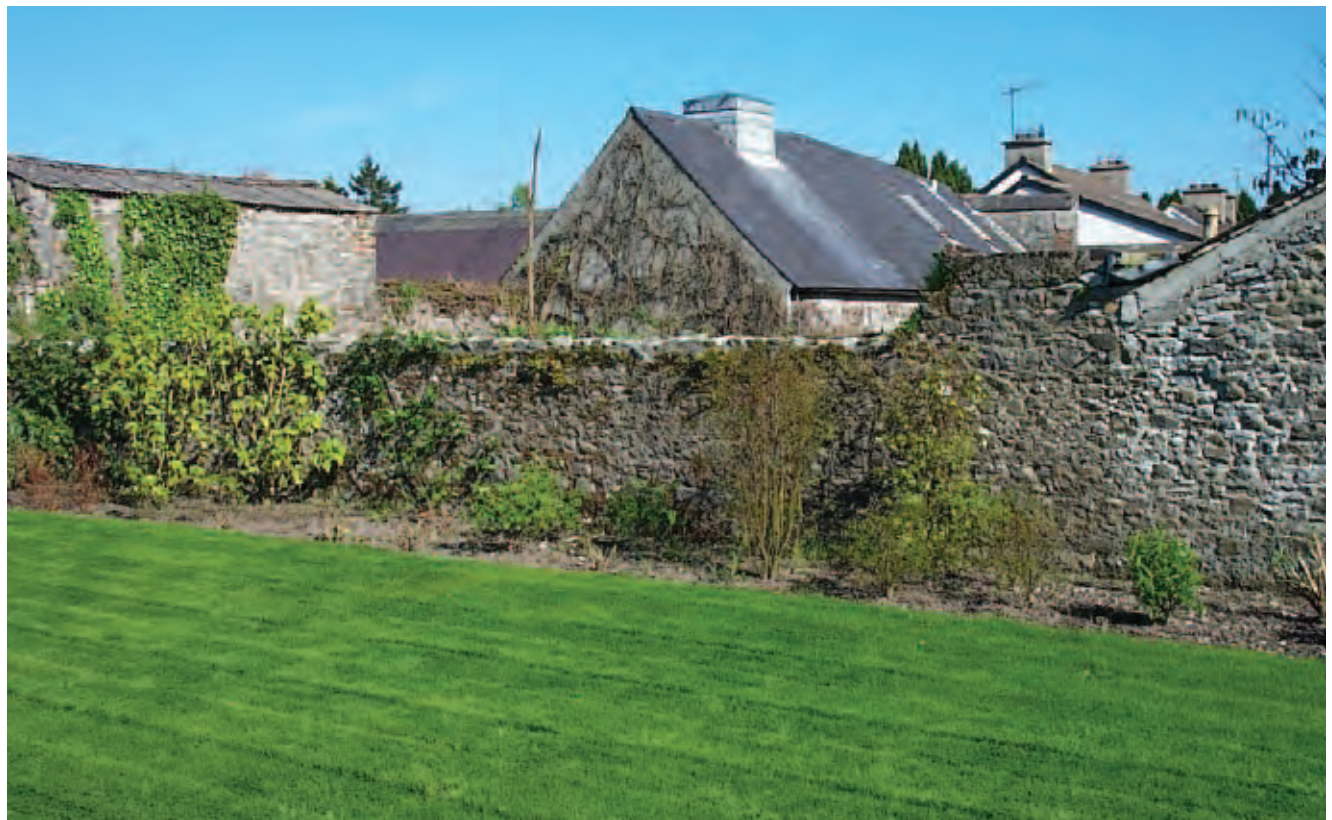
Plate 18: City Wall viewed from the north-west (interior) (May 2001)
