KILKENNY CITY WALLS

CONSERVATION PLAN

Oxford Archaeology

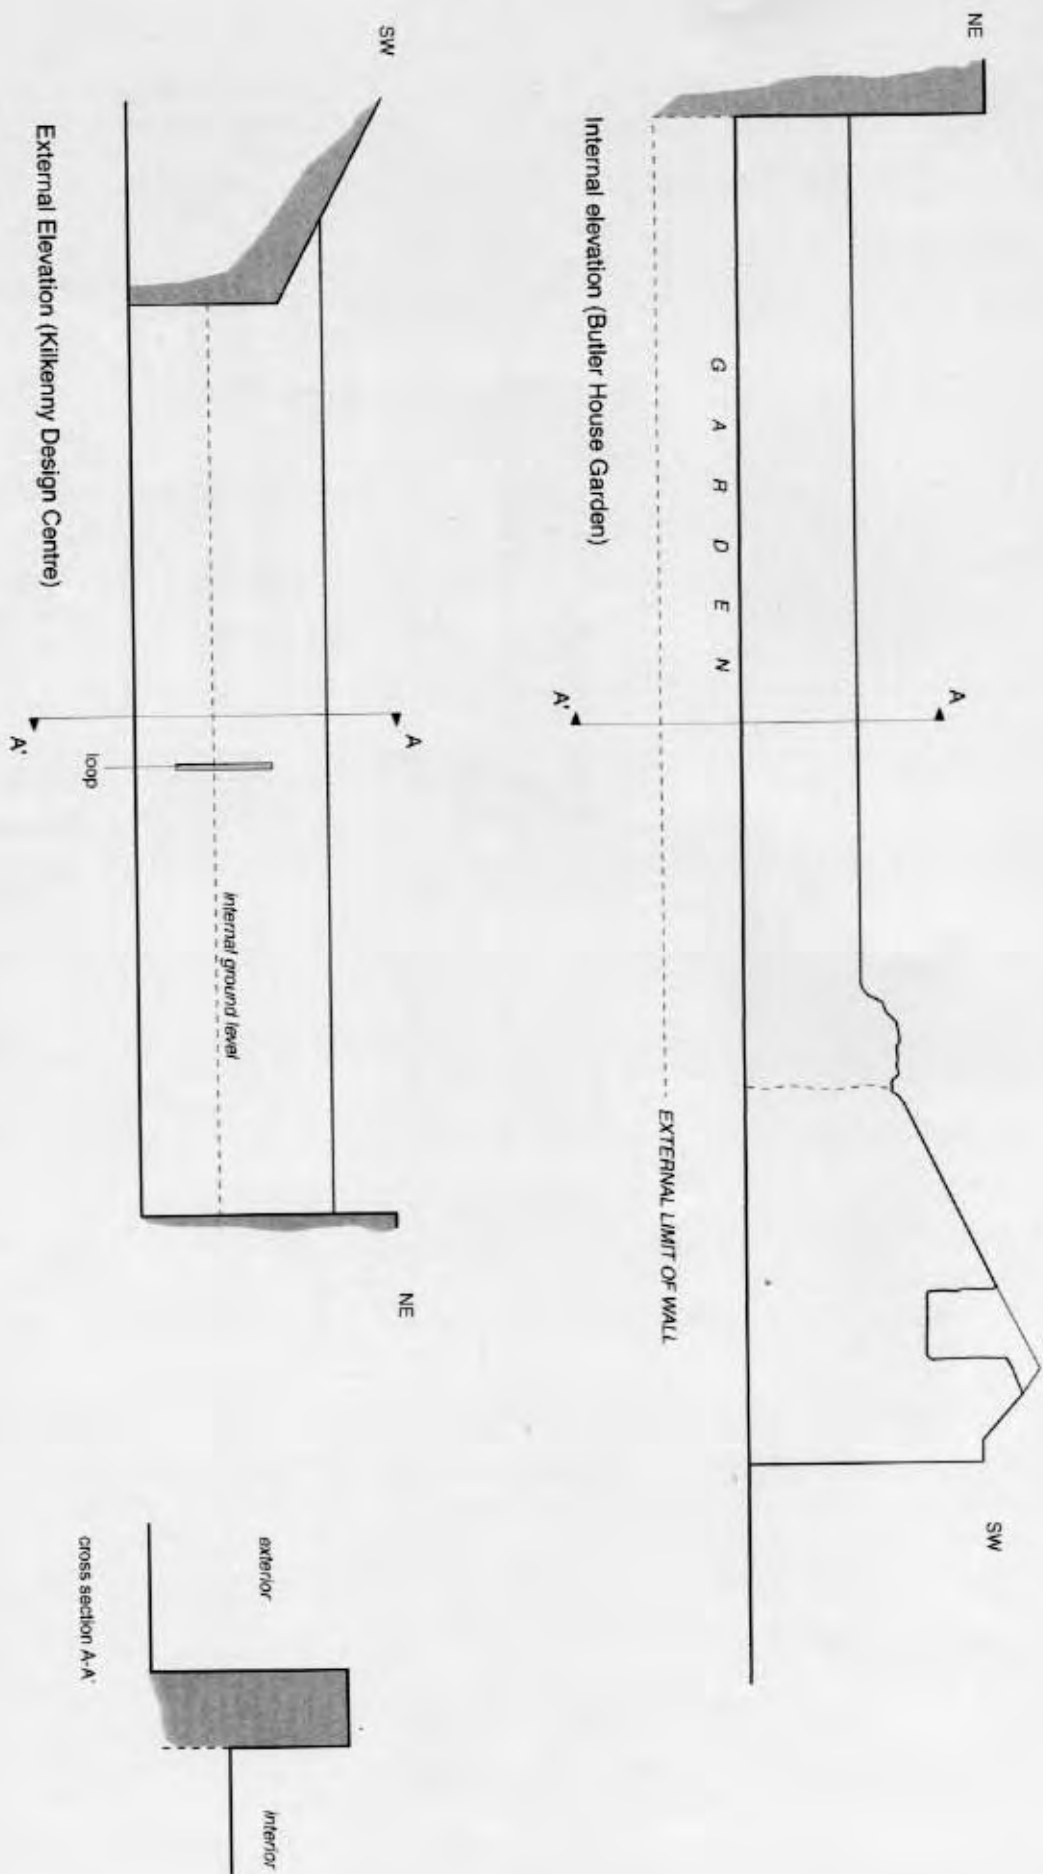
Figure 13: Kilkenny Design Centre. Internal and external elevations

The masonry is of roughly dressed and coursed angular grey limestone blocks. A single vertical loop is visible on the external elevation of the wall, measuring 1.25m tall by 0.08m wide. The loop is not visible to the internal face of the wall where it is obscured by the raised ground level.

- Detailed survey and analysis of surviving fabric. [Policy 14]
- Careful maintenance of vegetation growth on wall (removal of unsuitable woody species). [Policies 9, 11]
- Monitoring of condition of fabric to determine any need for repairs. [Policy 11]
- Establishment of maintenance regime. [Policy 11]
- Archaeological record of any alterations or maintenance works. [Policy 15]
- Consideration of display and access. [Policies 19, 20]

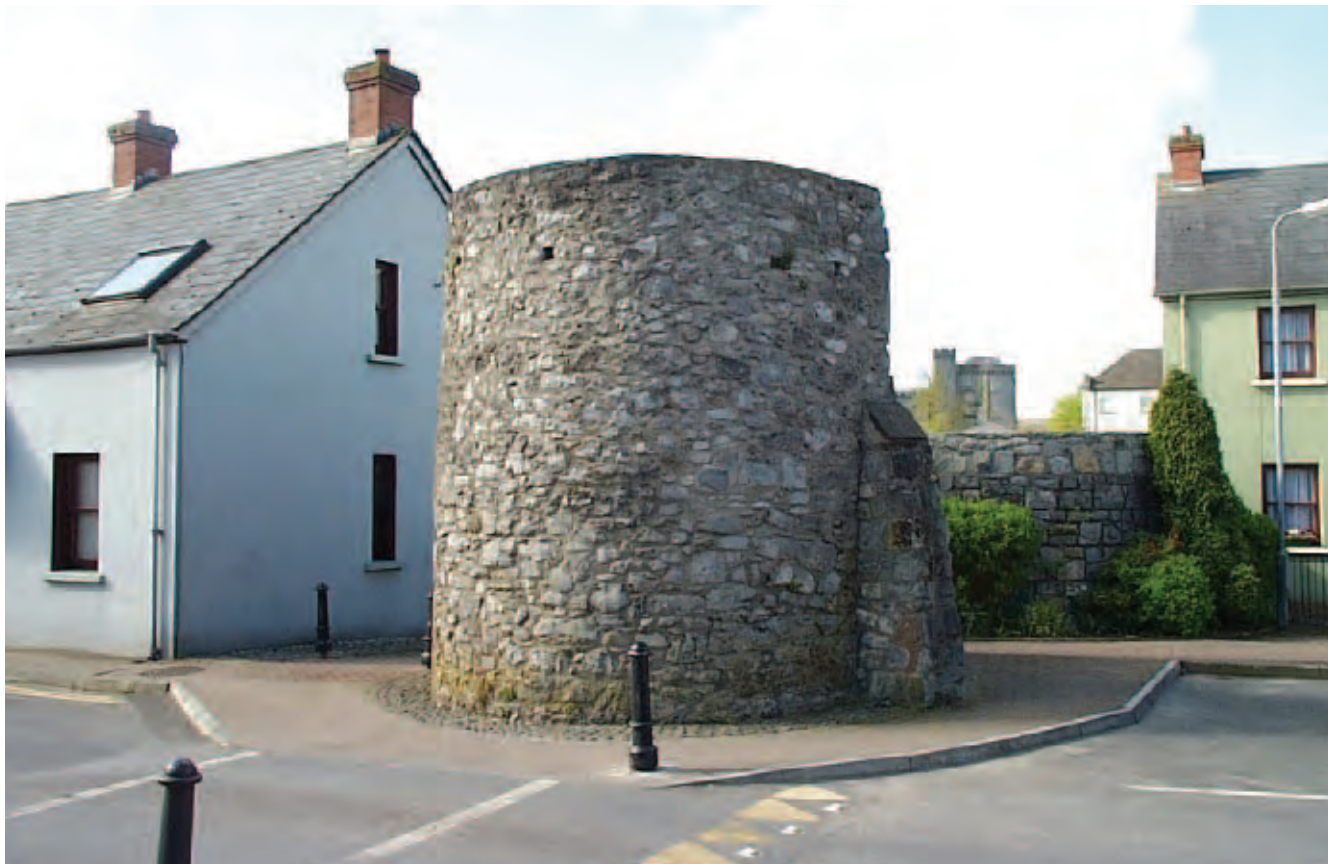
Plate 30: Corner tower from the north-east (May 2001)
